The Devastation of Garhwal Himalaya: Reminiscence of Kedarnath Flash Flood, June 2013

Abstract

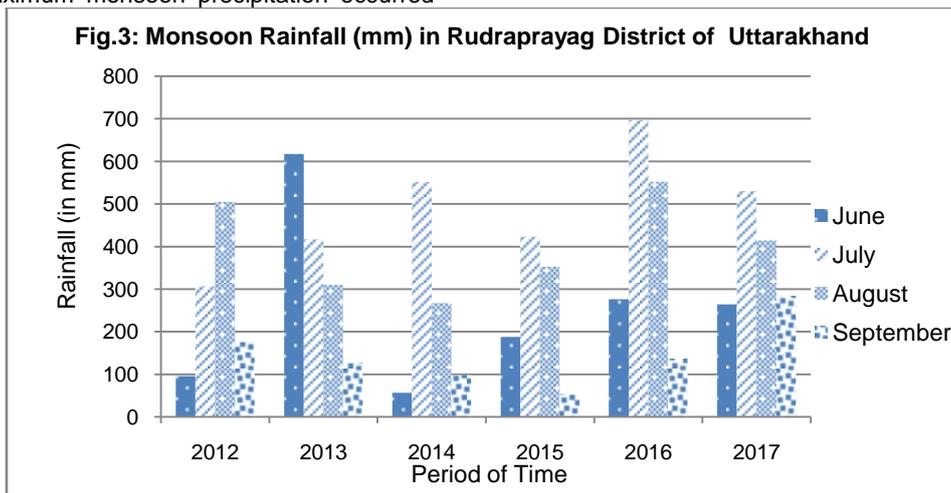
Fig. 3 is a histogram of Monsoon period rainfall pattern of Rudraprayag district representing the values of Table-1. The figure illustrates that generally maximum monsoon precipitation occurred

between July-August, while the district received heavy rainfall in June 2013 if compared from other years.

Table-1 portrays the Monsoon rainfall in Rudraprayag district of Uttarakhand occurred during June to September from the year 2012 to 2017.

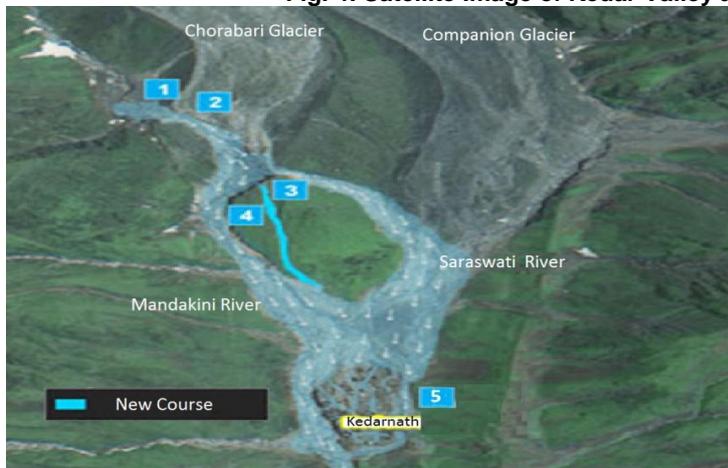
Fig. 4: Satellite Image of Kedar Valley after Flash Flood

Fig. 4 is a satellite image of Kedar valley taken after the flash flood June 2013 which adduces the happenings in Kedarnath [Singh, 2014].

A Satellite Image of Kedar valley:
(Taken after the Flash Flood)

1. Chorabari Lake,
2. Breached boundary of the lake,
3. The place where rock got removed and giving way to new stream,
4. The new stream,
5. Kedarnath town

It has been analyzed that the Kedarnath flash flood was a combined impact of extreme adverse conditions of the climate as well as the geomorphology of the region. In the extreme adverse climatic conditions, there were extremely heavy rainfalls, cloud bursts like conditions as well as arrival of monsoon before its schedule when the melting of snow and glacier was on its peak. Thus, heavy rainfall stimulated the melting of snow. Heavy down pouring as well as rapid melting of snow flooded the Chorabari Lake and Mandakini river rapidly. This rapid increase in the water level at Chorabari Lake created pressure on its boundary resulting into outburst that aggravated the flash floods in Kedarnath and surrounding areas. Chorabari lake is a glaciated moraine lake and has a fragile boundary. Therefore, it could not bear the heavy pressure of water and resulted into an outburst flood. The Kedarnath is surrounded by snow-capped

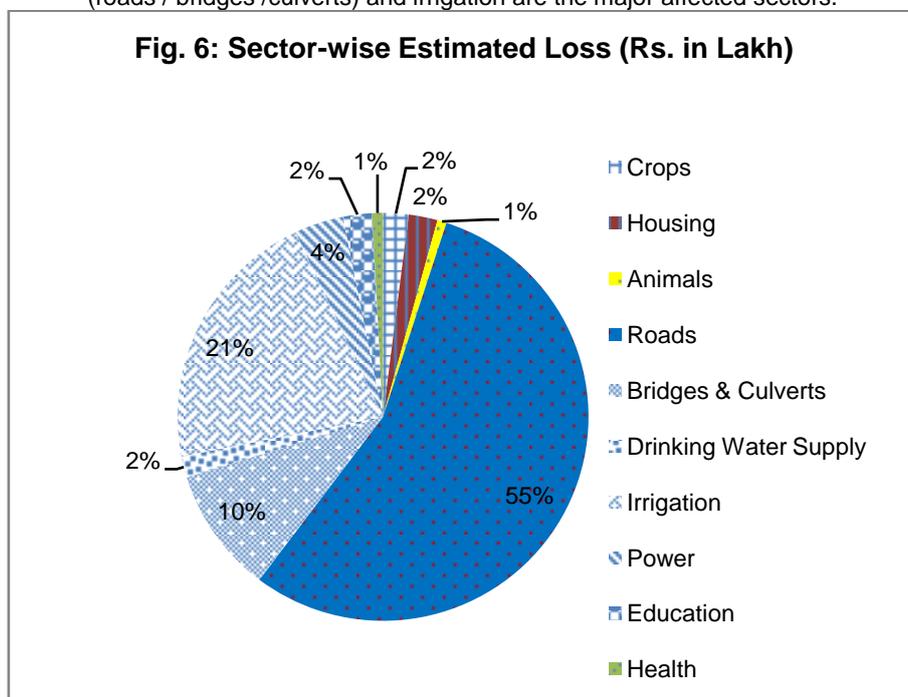
Fig. 6 illustrates the sector wise estimated loss in the form of a pie-diagram. This further clarifies that infrastructure (roads / bridges /culverts) and irrigation are the major affected sectors.
