# Slope Stability Assessment of Most Flash Flood Effectuated Villages Near Uttarkashi Town

**Himanshu Sajwan**

**H. P. Bhatt**

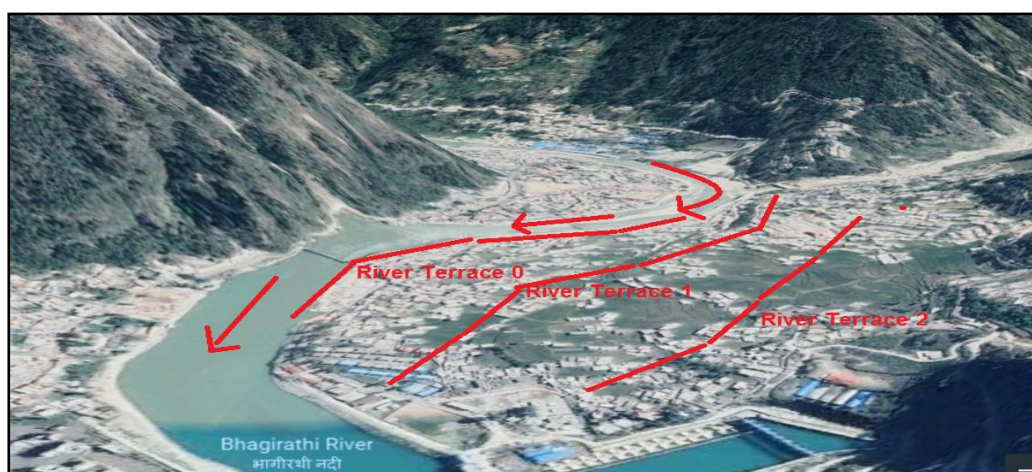
The Tiloth village has population of 2994 of which 1618 are males while 1376 are females as per Population Census 2011. The village is situated on the T1 level of Bhagirathi River and being used for inhabitation and cultivation. About 700m stretch along left bank of river has been badly affected due to toe cutting during insistent rain and flash flood. About 70 families are residing in the village; three houses in the village have completely washed out whereas 16 houses have been badly damaged. In the downstream of bridge, store and residential quarters of UJVNL have also been damaged partially. The incidence took place during day time on 17th June, 2013 therefore, there was no human casualty. River bed level is 5m-8m below from the habitants and the

bank protection measures which have been adopted are inadequate. The foot track (> 1km long) which was constructed during the high flood has also been eroded and washed away completely. The right abutment of the only bridge, (constructed in the year 1976) connecting Tiloth village with Uttarkashi town, was also damaged and washed out. River bed level at many locations has been raised by 2m-3m due to accumulation of the sediments in the form of boulders, pebbles, cobbles silt and sand etc. In August 2003, flash flood washed out many buildings located on right bank whereas during the present disaster damage occurred on the left bank due to change of river course.

1. Immediate restoration of the foot track by constructing concrete wall with deep foundation (below scouring depth) and height should be at least upto high flood level along with weep holes.
2. One row of boulder crate wall towards river side to protect concrete wall in the event of high flood.
3. Further construction practice in the flood plain/ T0 level should be strictly prohibited.
4. Dredging of the river bed in planned way by removing sediments in the form of pebble gravel, cobbles, boulders, etc. which help free flow of discharge during monsoon.
5. In the cultivated land controlled irrigation should be adopted.
6. At the confluence of one unnamed *nala* with Bhagirathi river about 600m upstream, damage to few houses has been noticed. Bank protection along this *nala* is also suggested.

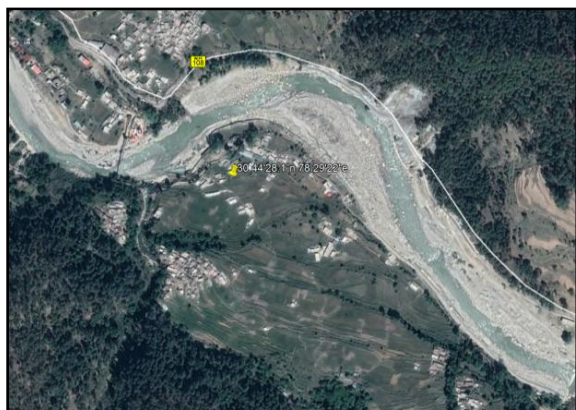
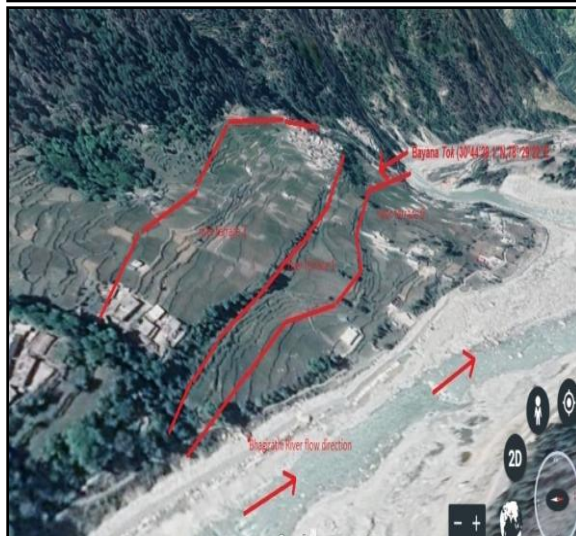
crown is receding towards hill side in rainy season causing threat to the inhabitants. The problem of landslide aggravated manifold during monsoon in the month of June 2013 due to toe cutting by the river Bhagirathi and heavy discharge along two seasonal *nalas* on either side of the village. but due to flash flood the discharge of Bhagirathi reached above 5m and started toe cutting resulting failure of material and sliding of few houses towards the river. On the basis of preliminary geological inputs and history of the slide, it is recommended to shift the affected families to a safer place nearby the village because day by day the crown is receding and seasonal *nalas* are engulfing the land from both sides and Bhagirathi is continuously eroding the toe of the land where the village is situated.

District administration is planning to shift the affected families in the Bayana Tok (30°44'28.1"N, 78°29'22"E, Elevation ±1230m, 53J/6) hamlet of main Siror village. The proposed land which is located on the flat terrace on the left bank of the Bhagirathi River (~ 100m SW) and which is presently under cultivation. The location is opposite to famous Naitala landslide and presently the flow of the Bhagirathi River is towards right bank.

Prima facie, the proposed land appears feasible, however, it is advisable to adopt all the stability measures like deep foundation, earthquake resistant structure and good drainage arrangement and isolate the proposed land from adjoining irrigated land to avoid any seepage below the foundation of the houses.
