# Impact of Tehri Dam Reservoir on Geomorphology of the Area

## Abstract

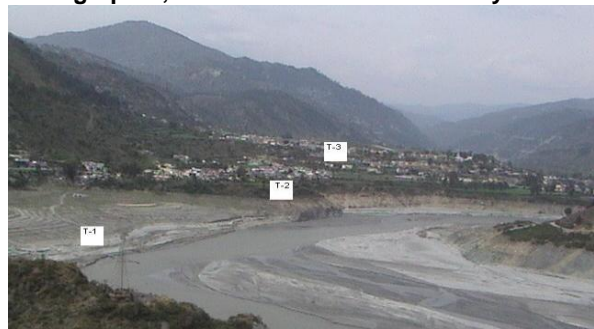
**Photograph-1; Terraces of Chinyalisaur**

Along the Bhagirathi terraces are developed at Badethi, Chham, Chinyalisaur, while most of the terraces like Dobata and Tehri were submerged in the Reservoir. The terraces are mainly comprises of boulders, cobbles and pebbles embedded in silt and sands. In the Bhagirathi river Naithani (1992) observed 5 level of terraces similarly five level of terraces denoted around Chinyalisaur. T5 is the oldest terrace which is mainly comprises of clay horizon intermixed with boulder, cobbles and pebbles which are angular to sub angular may be of glacial origin. T4 terrace is less developed and is mainly comprises of gravels embedded in brown clay horizons, T4 terrace height is about 30 to 35 meters. T3 terrace is well developed and colony of hydropower project and school and market is also well developed here. Terrace is mainly comprises of silty and sandy horizons with sub angular to subrounded cobbles and pebbles. T2 terrace is also developed in Chinyalisaur about 7-10 meter, mainly comprises of subrounded to rounded pebbles with coarse and fine sand layers. T1 terrace lie near the flood plain and is comprises of fine and

coarse sandy layer and generally submerged under water during rainy season. At Kandisaur T1,T2,T3 and T5 terraces are well developed but T3 is well developed and is about 800 mts length and 500 mts in width and is used for cultivation and human settlement. other are developed around Ratnogad and Badethi and Jakh village near Koti.

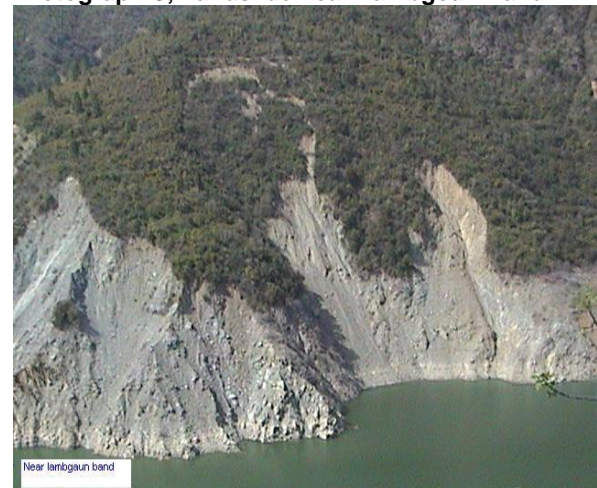
**Photograph-5; Landslide near Lambgaon Band**

Latitude	30°22'14"N
Longitude	78°33'30"E
Height	80 meters
Width	250 meters

The landslide is located at the right bank of reservoir rim near the lambgaon band 2 km ahead of Gadolia (photograph-5). The general topography of the slide is moderate to steep faces with the right face of the slide being more steep. The upper part of the slide has thick shrubs and forest cover. The rocks are mainly phyllite mixed with unconsolidated clay with angular to subrounded boulders and cobbles overburden. It is an active debris slide.

2. Water is the major factor producing slope failure. Near Baldogi, Lambgaon band, zero bridge and Nagun gad due to slope failure and slacking effect these villages sliding down, and villagers demands for rehabilitation.

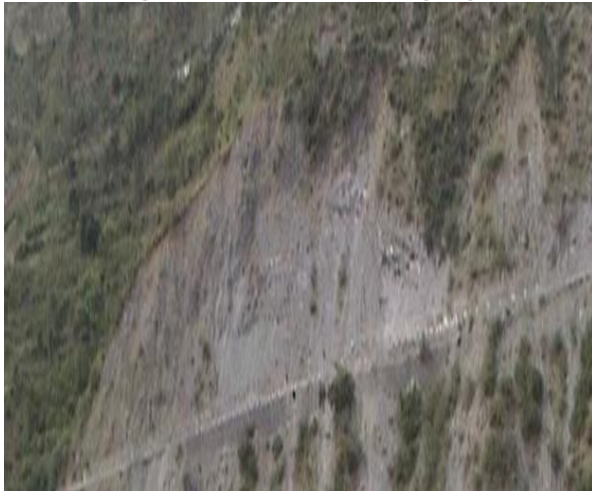
**Photograph-6; Landslide of Nagungad**

Latitude	30°33'N
Longitude	78°20'E
Height	40 meters
Width	250 meters

Due to construction of road Chamba-Dharasu at the left side of downstream of Nagun gad (photograph-6). The active landslides were observed. It is about 250 mts in length and 40 mts in height. The bed rocks are highly jointed phyllites with overlying loose clay material. In both the places, widening and the construction of roads is the cause for slope failure.

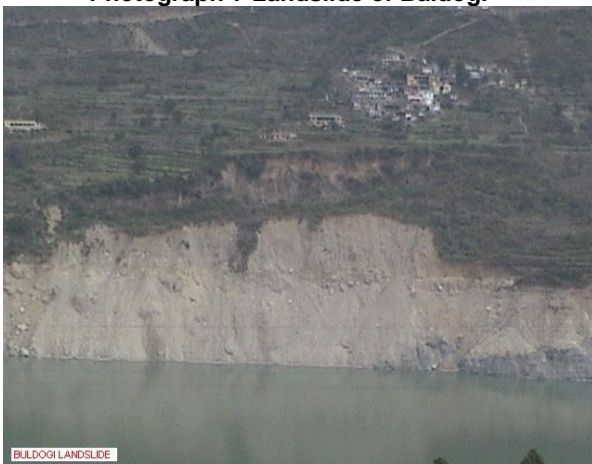
**Photograph-7 Landslide of Baldogi**

Latitude	30°31'N
Longitude	78°23'E
Height	200 meters
Width	180 meters

This landslide is located near village Baldogi on the left side of the reservoir rim (photograph-7). The slide has a clayey sandy matrix in which loose boulders and pebbles are visible. The upper part of the slide has a thick vegetation cover. The slide does not have a single failure plane instead multiple planes of failure exists for the sliding mass. As the photographs shows that there is a crack below Baldogi village and therefore it poses a serious threat for the village, during heavy precipitation the village may slide down in near future.

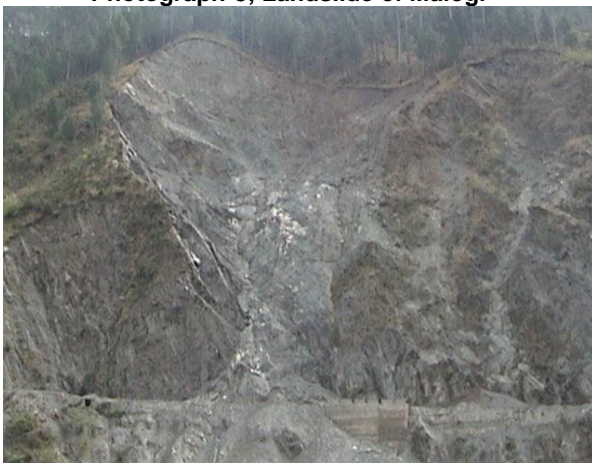
**Photograph-8; Landslide of Malogi**

Latitude	30°22'N
Longitude	78°22'E
Height	500 meters
Width	300 meters

The slide is located near Malogi gad on the right bank of the reservoir rim (photograph-8) It has an irregular outline with moderate slope. The land upside of the slide is covered with thick forest cover. The slide material consists of loose soil debris and fragments of rock material.
